# **U.S.S. TEXAS (BB-35)**

## **OPTION 5 TANK INSPECTION AND REPAIR ASSESSMENT**

Vessel Survey Report No. 2443

Vessel surveyed: U.S.S. TEXAS (BB-35)

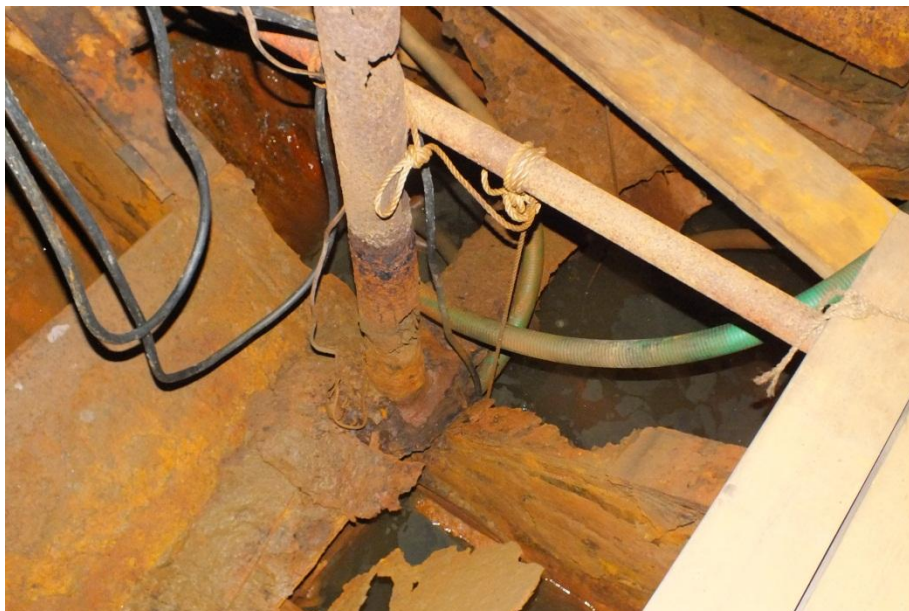
Figure 69: Base of Centerline Wasted Stanchion Resting on Wasted Pedestal over Keel in D-12 Trimming Tank

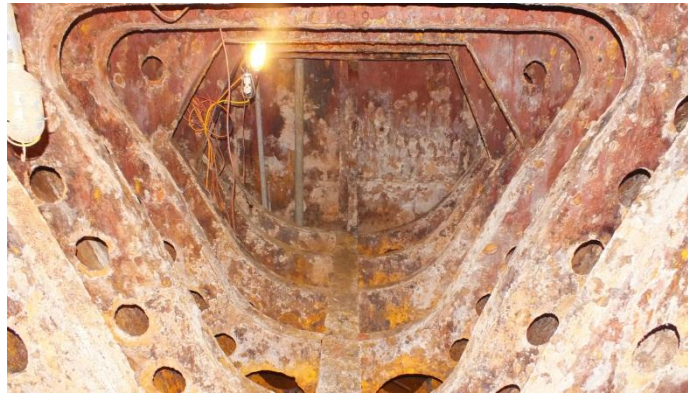
The overhead frames and deck are in poor to fair condition and will be replaced as the heavy steering rams and rudder post ride on this deck.

**Figure 70: D-13 Trimming Tank, looking forward to Bulkhead at Frame 129**

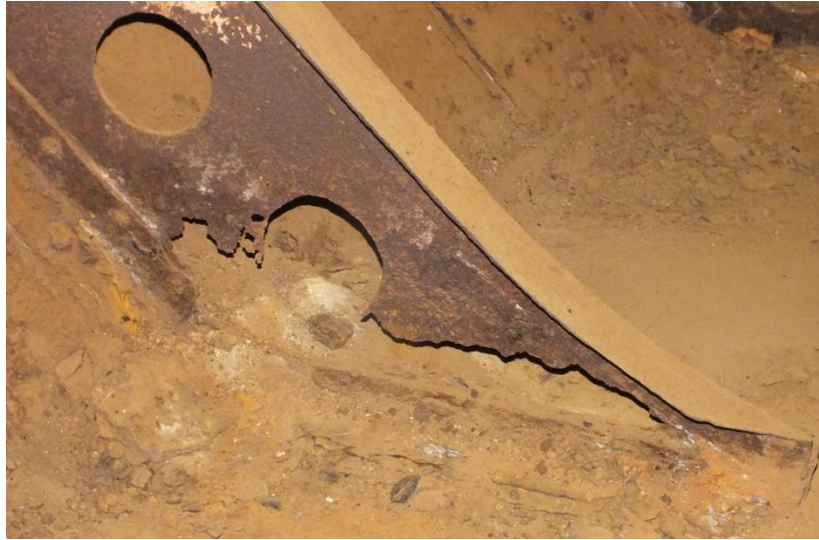
The Steering Gear Room (D-27) sits atop the Trimming Tank (D-13) and is an open area with the heavy hydraulic components of the steering rams and rudder post. The deck is in poor condition and must be replaced. The bottom 4' of the side shell transverse frames are also in need of repair/replacement.

**Figure 72: Typical Base of Transverse Frame within D-27**

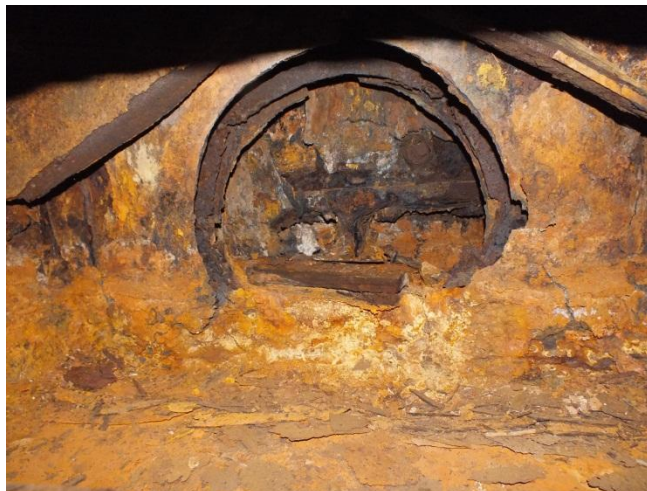
Figure 74: Badly Corroded Scantlings Aft of Rudder Post

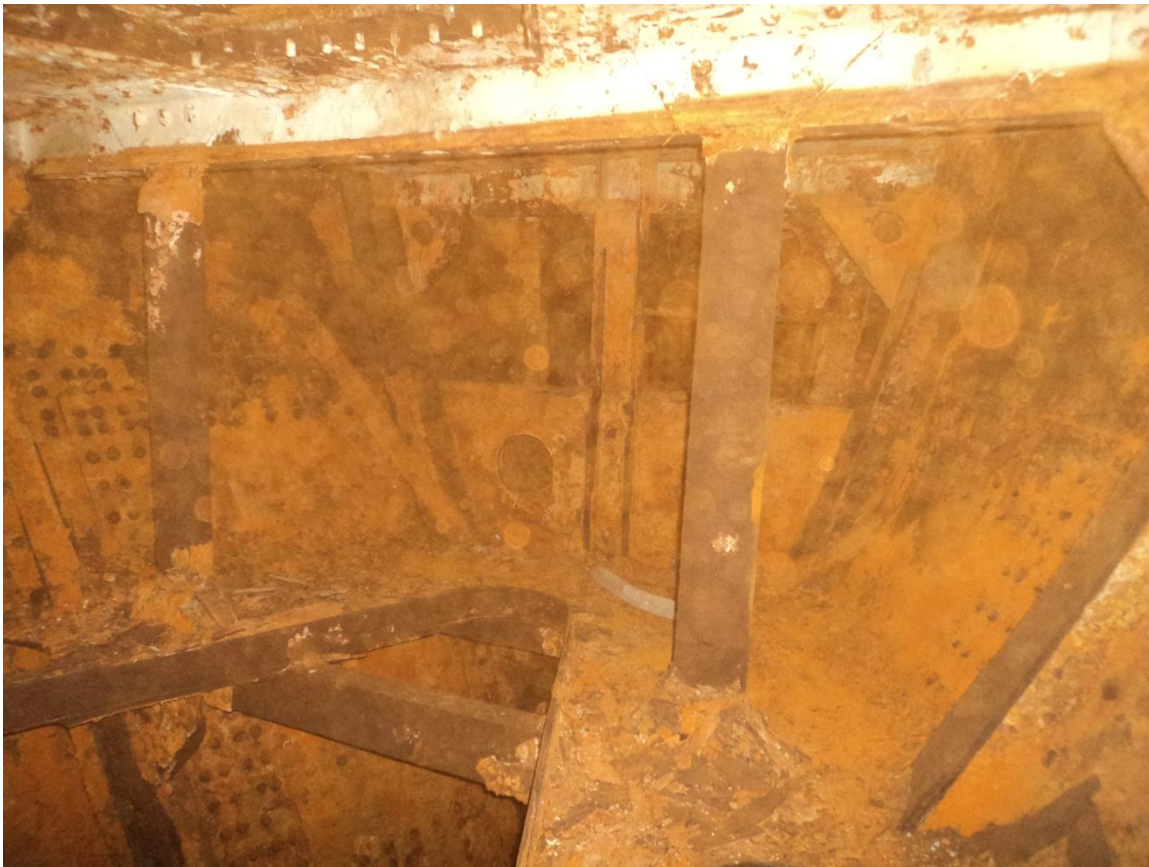
A large space just aft of the rudder post at the very stern of the ship. This space has large apron frames from top to bottom within this tank. All scantlings are heavily corroded due to poor drainage from weatherdecks. There are holes in the shell plating above the waterline to the exterior and cofferdam tankage above is heavily wasted and badly corroded.

**Figure 75: Upper Portion of D-107, showing Heavily Corroded Scantlings**

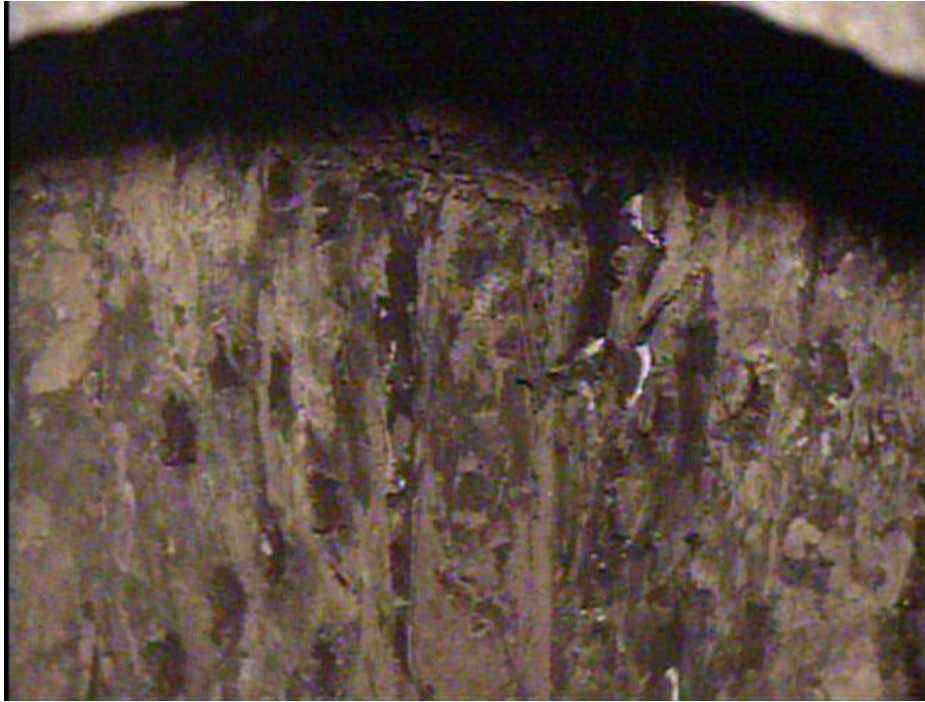
**Figure 76: Stern Casting, showing Daylight through Wasted and Holed Shell Plating on Centerline above Waterline**

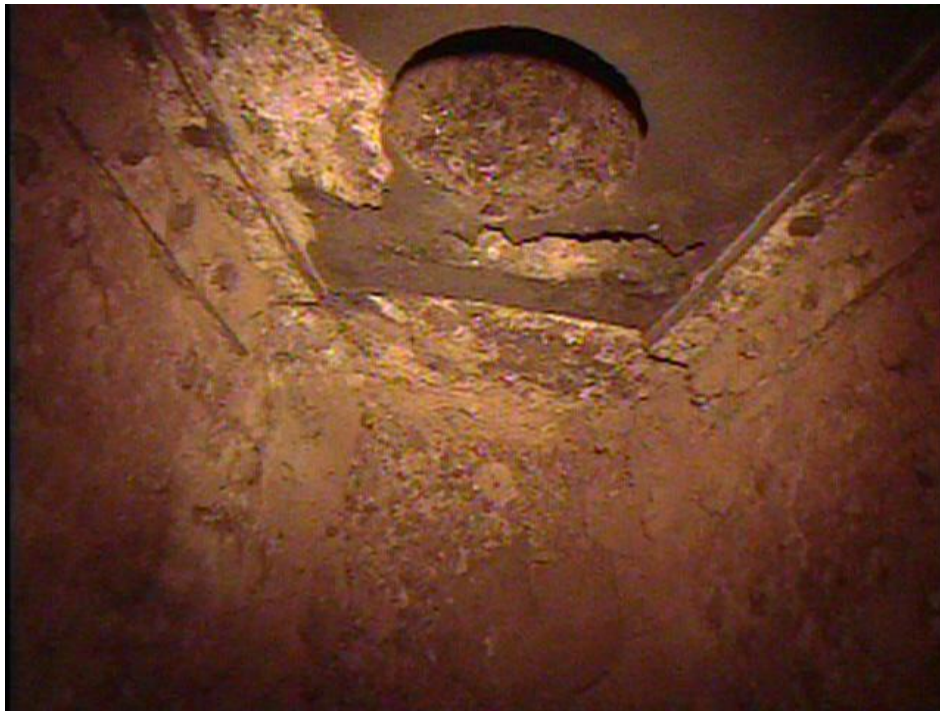
**Figure 77: Heavily Wasted Transverse Frame at Base of Compartment**

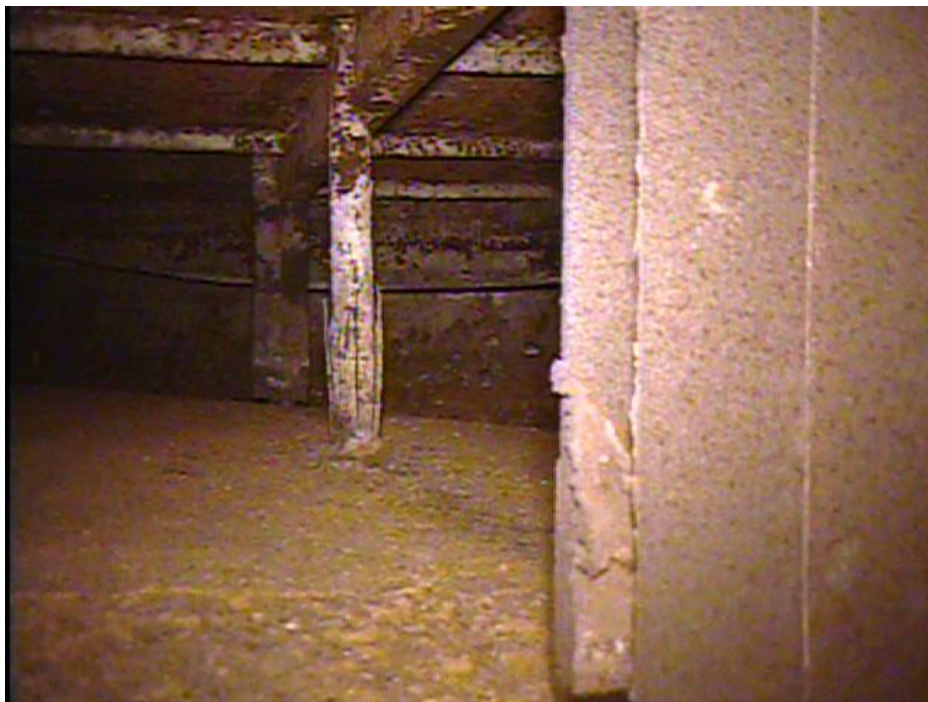
**Figure 80: D-102. Looking across Turtle back to Starboard Showing Wasted Vertical Stanchions**

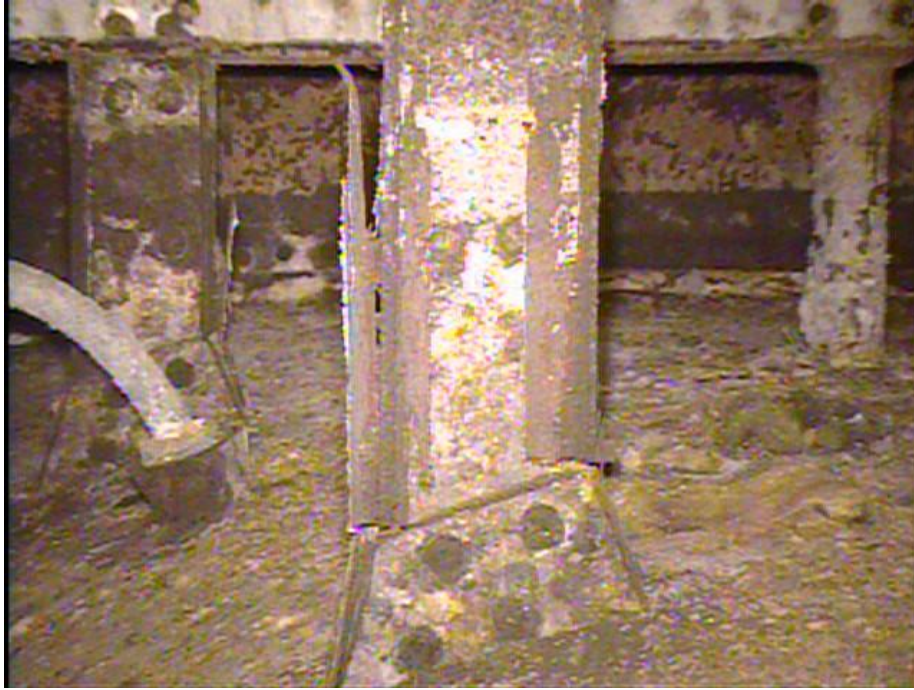
**Figure 81: Wasted Vertical Stanchion. Typical throughout D-101, D-102 & D-103.**

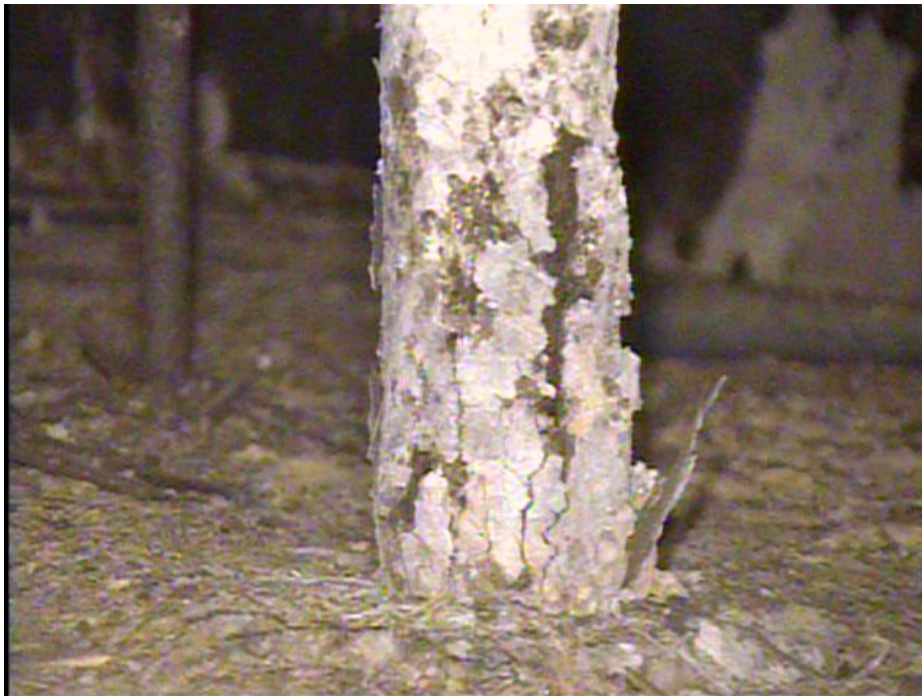
**Figure 82: Wasted Vertical Stanchion**
